Indicative fire test

332065

Intumescent Systems Ltd

The purpose of the investigation was to provide an indication of the behaviour of a section of a timber floor protected on its underside by a plasterboard ceiling incorporating three speakers and associated covers, when subjected on its underside to the heating and pressure conditions specified by BS EN 1363-1: 2012.

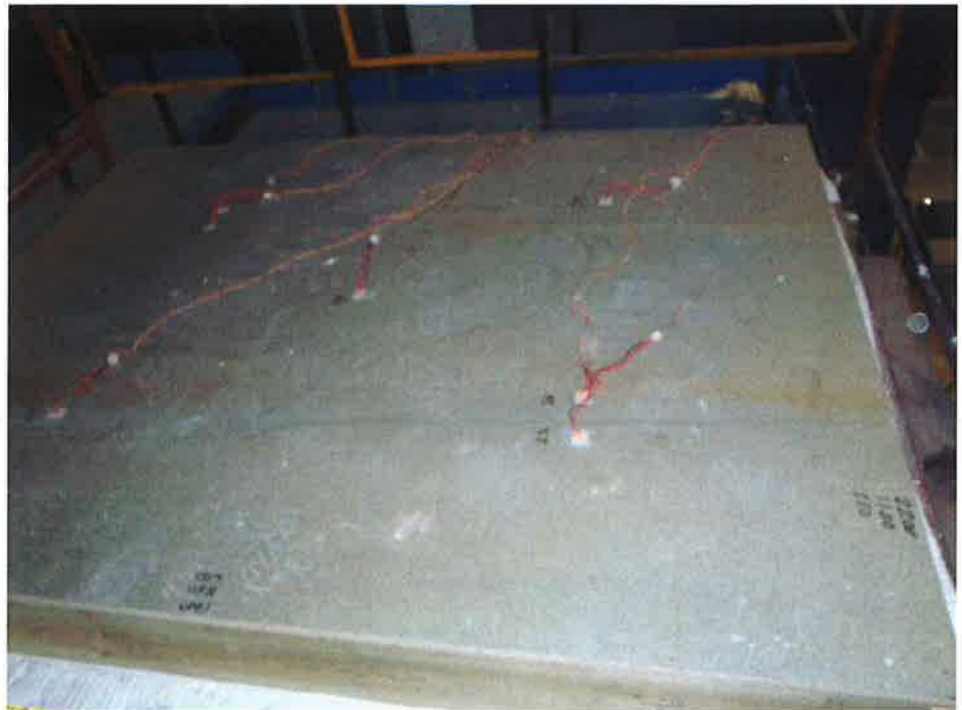
**The unexposed
face of the ceiling
after a test
duration of 30
minutes**

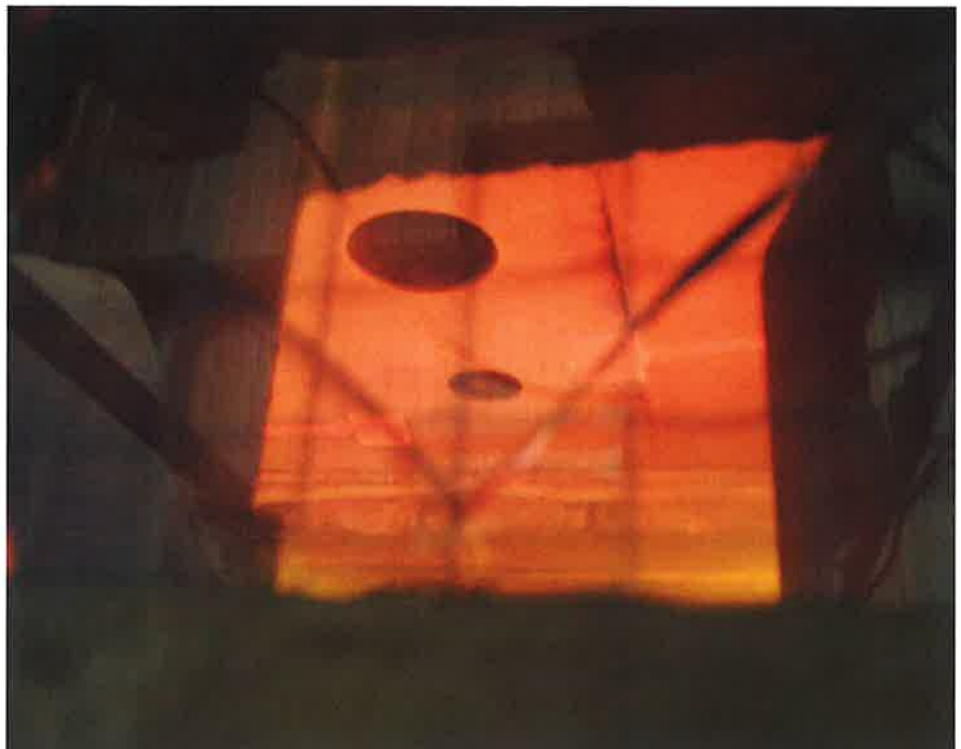
**The exposed face
of the ceiling after
a test duration of
30 minutes**

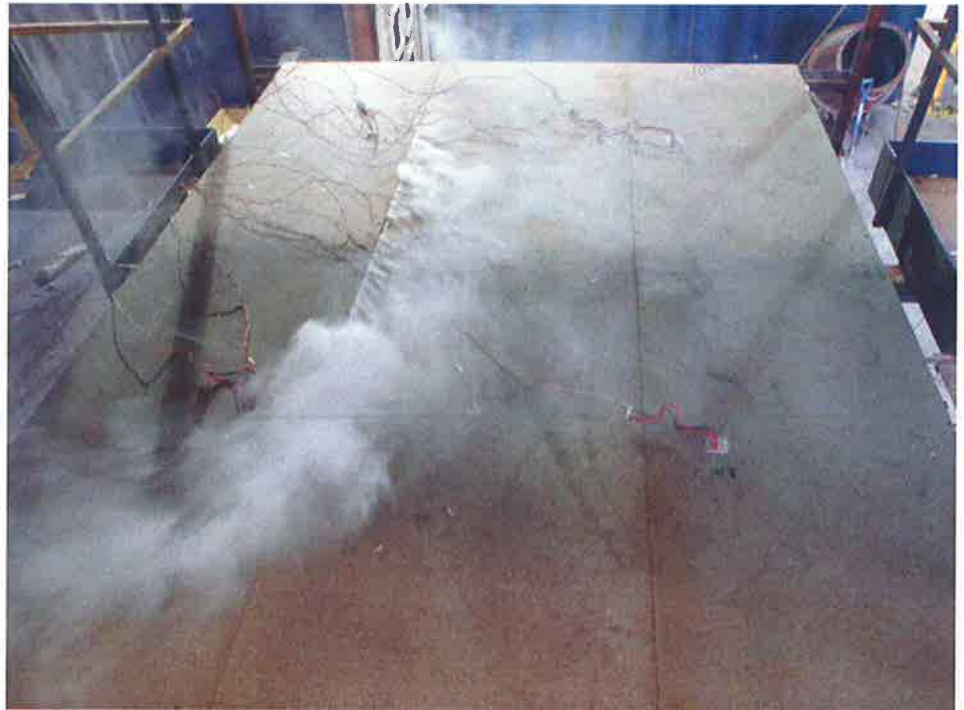
The unexposed face of the ceiling after a test duration of 90 minutes

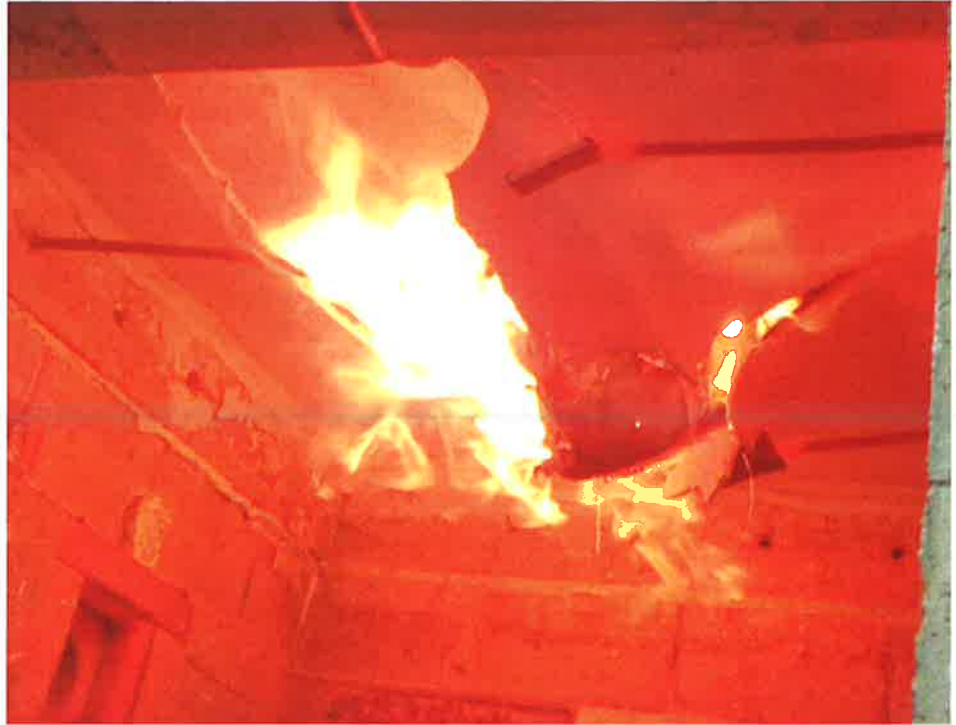
**The exposed face
of the ceiling
immediately after
the test**
