Determination of the resistance to fire, according to EN 1365-2:2014 of a wooden floor construction protected with Envirograf[®] Intumescent timber frame fire retardant coating system 42 HW01

Report no.	2018-Efectis-R000437
Sponsor	Intumescent Systems Ltd Envirograf House Barfrestone CT15 7JG DOVER Great-Britain
Product name	Product 42 HW01
Prepared by	Efectis Nederland BV
Notified body no.	1234
Authors	P.G.R. Scholten B.Sc. R.D. Scheepe B. Sc.
Project number	ENL-17-001253
Test date	06 February 2018
Date of issue	March 2018
Issue	1
Number of pages	25

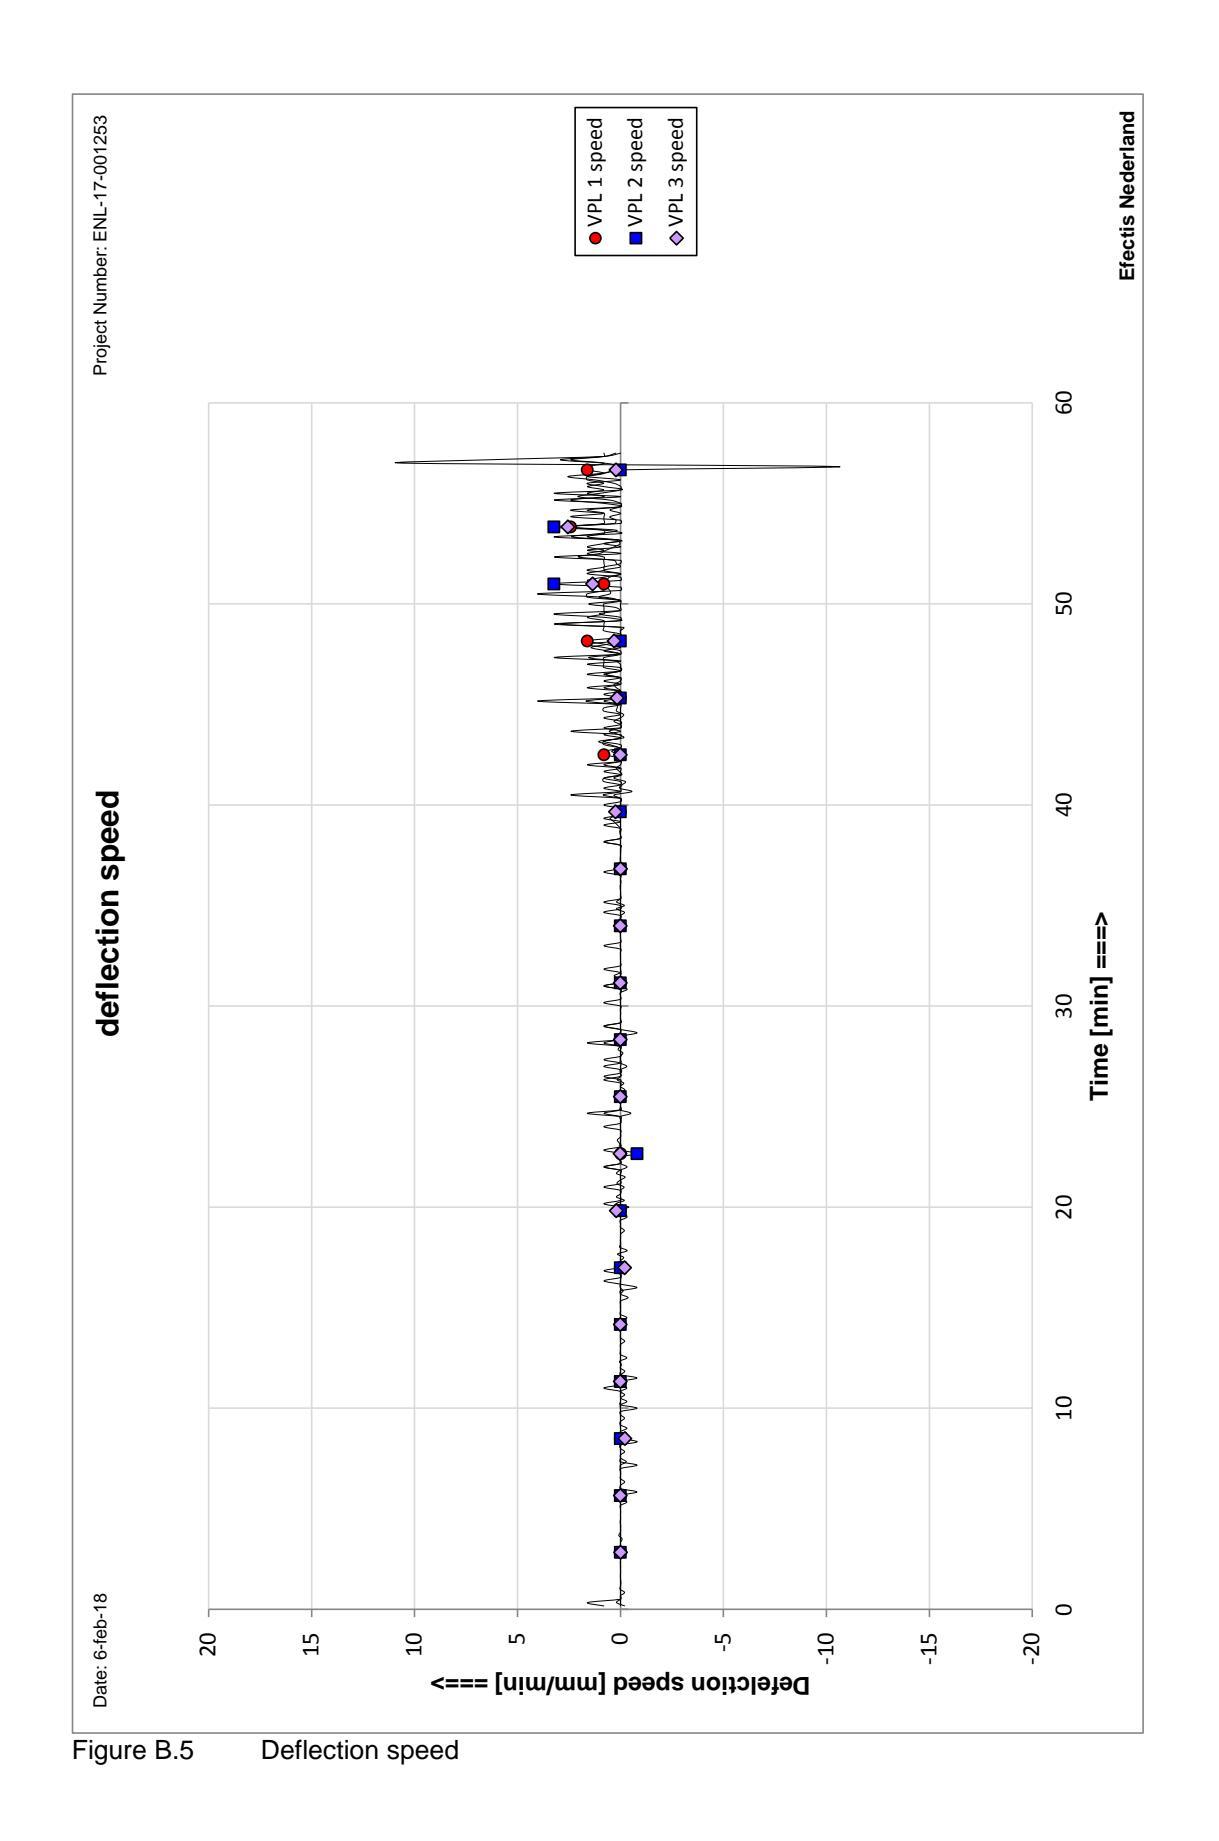
Criterion	Time (min.)	Result
 Loadbearing capacity (R) Deflection, limit 116 mm Date of deflection, limit 5.2 mm (min) 	57	16 mm
 Rate of deflection, limit 5.2 mm/min Integrity (E) 	57	10 mm/min
 Cotton pad Gap Gauge: 	57	Not determined
Ø 6 mm	57	Not determined
Ø 25 mm	57	Not determined
 Sustained flaming > 10 seconds 	57	Failure
Insulation (I)		
 Average temperature 	57	No failure
 Maximum temperature 	57	No failure
The heating was terminated after 58 minutes after consulting the client.		
Classification according to EN 13501-2 could be described in a separate report. The construction could be classified as follows: RE 30, REI 30 and REI 45

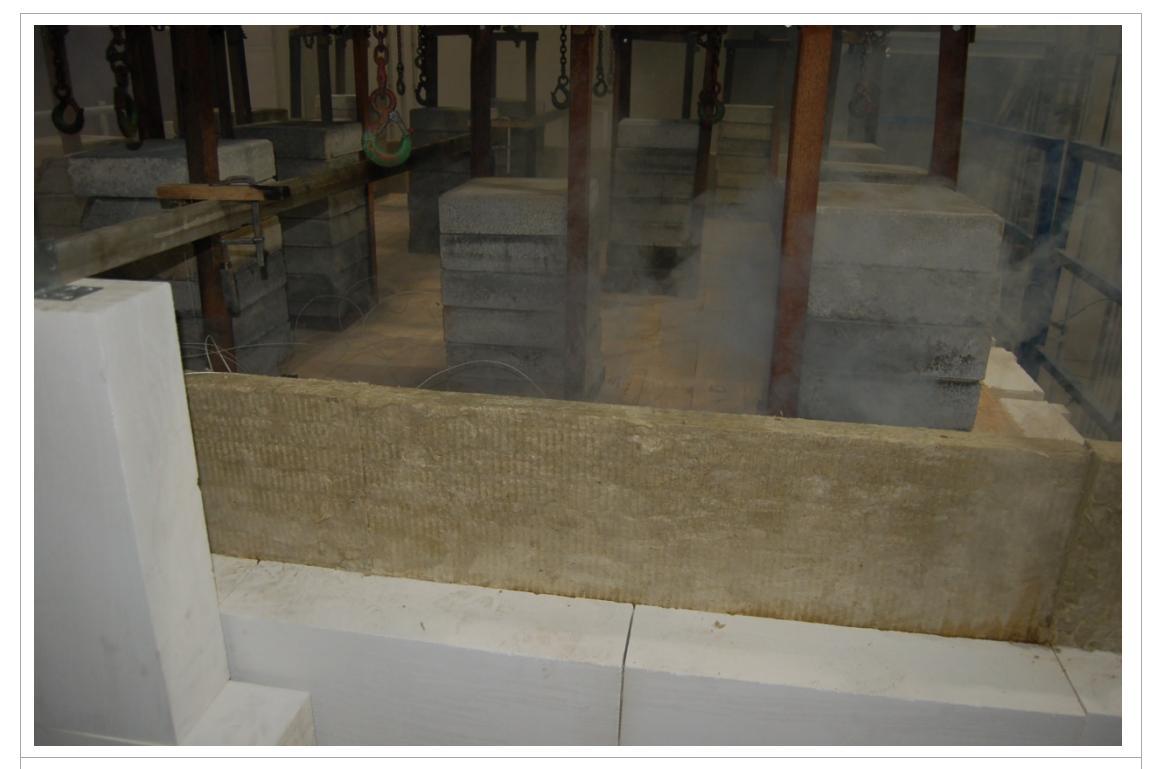
Photo 5. Specimen after 19 minutes of heating

Time (min)	F/N	Observations F = Fire side, N = Non-fire side
0	F	Start of heating
3	Ν	Smoke appears out of the free edge
14	Ν	Smoke appears out of the seams of the floorboards, near thermocouple 5
20	N	Amount of smoke increases and smoke appears out of more seams
25	N	The floor discolours black at the seam near thermocouple 4
30	N	Applying the roving thermocouple at the discolouring: T= 49°C
35	N	The coating on the joists is foaming at the unexposed side of the joist
44	N	The discoloured place does not change
55	N	More discoloured spots appear at the seams of the floorboards
55	N	Orange glowing in the corner of the floor, near thermocouple 2
57	N	Flaming > 10s near thermocouple 1 & 5
58	F	End of heating after consulting the client
